# Manhole Inspection Summary

Manhole # S27I\_\_019MH

**Location** Address: **1000 S.Schroeder St.**

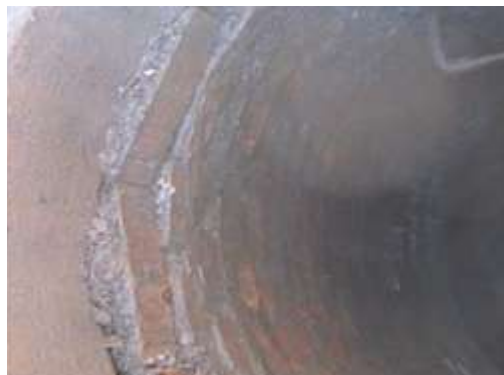
Defect 6

Condition: ☐ Sound ☐ Cracked ☐ Root Intrusion ☐ Loose Brick ☒ **Deteriorated**

Infiltration: ☐ None ☒ **Joint** ☐ Cracks ☒ **Mortar** ☐ Roots ☐ Wall

chimney deteriorated with infiltration at mortar & joint

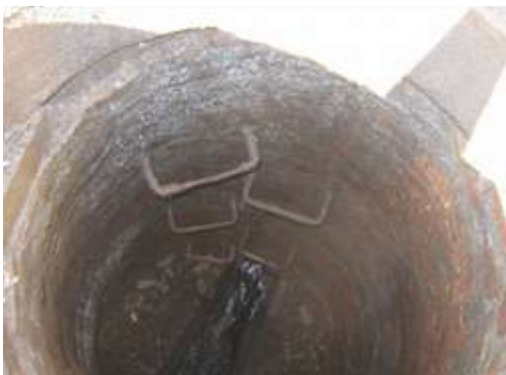
Defect 5

Infiltration: ☐ None ☐ Joint ☐ Cracks ☐ Mortar ☐ Roots ☒ **Wall**

Count: **5** Missing: **0** ☒ **Corroded**

corroded rungs with chimney and corbel infiltration at walls

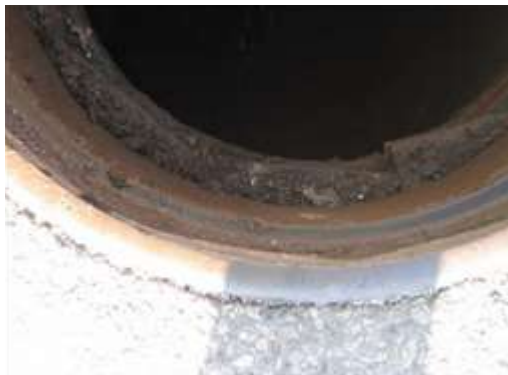
### Defect 3

Offset: **1.5** (in.)

frame offset 1.5 inches

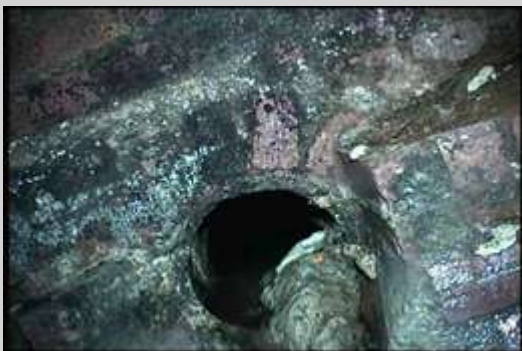
2 O'Clock Inflow

connection is under mh shelf and cannot be  
see from top view

Deposits: ☐ None ☐ Mud ☐ Sludge ☒ **Debris** ☐ Grease

Silt Depth: **3** (in.) Deposits Extent: **Medium**
